Titanic, The Anatomy of a Disaster

A Report from the Marine Forensic Panel (SD-7)

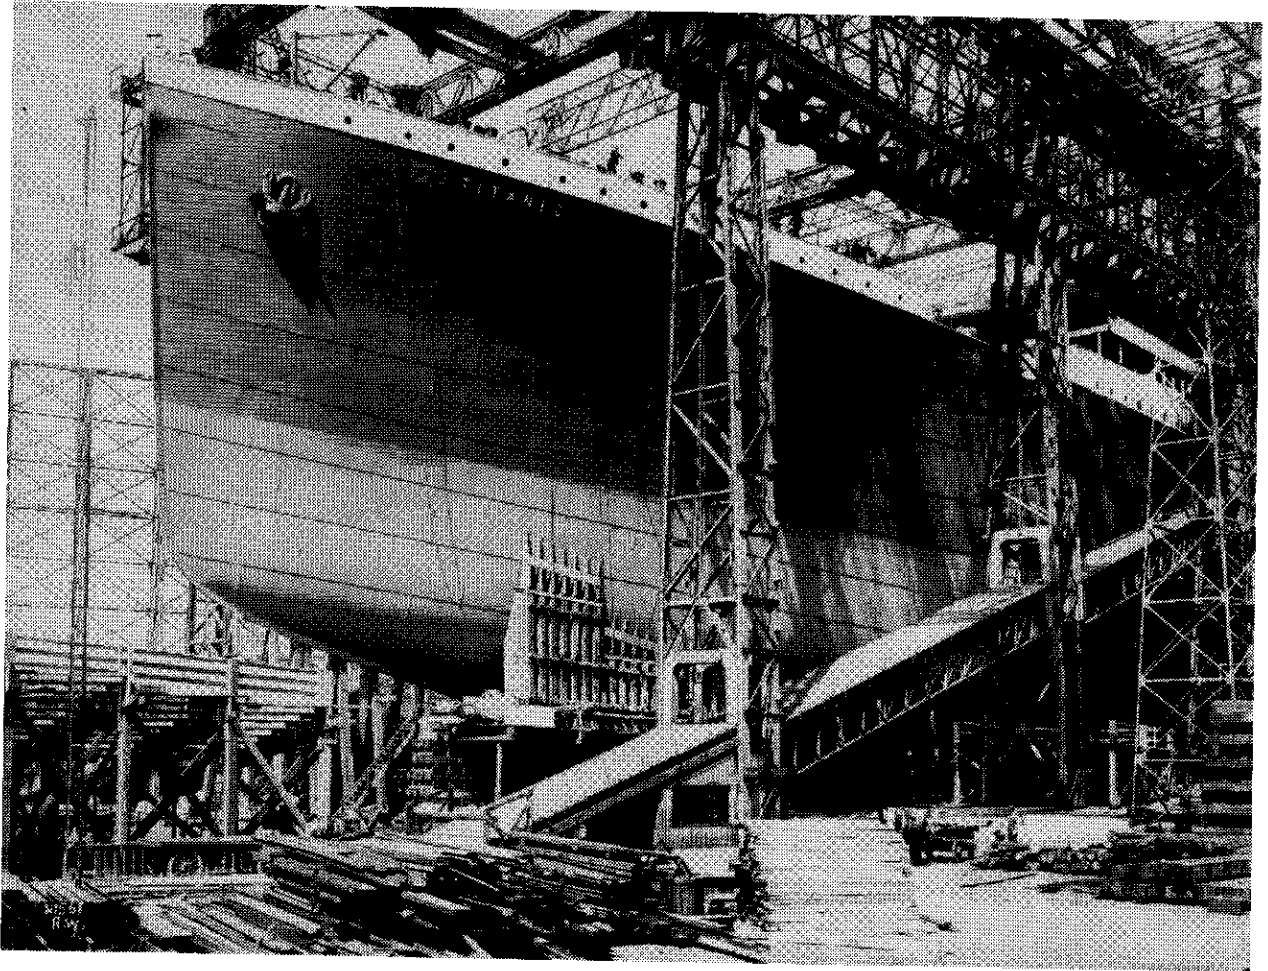
The Titanic is perched on the building ways at Harland and Wolff Shipyard on May 31, 1911 several hours before her launch. Note that the second full plate within the boot topping is the plate that sustained damage from the encounter with the iceberg on April 14, 1912. (Courtesy of the Ulster Folk & Transport Museum)

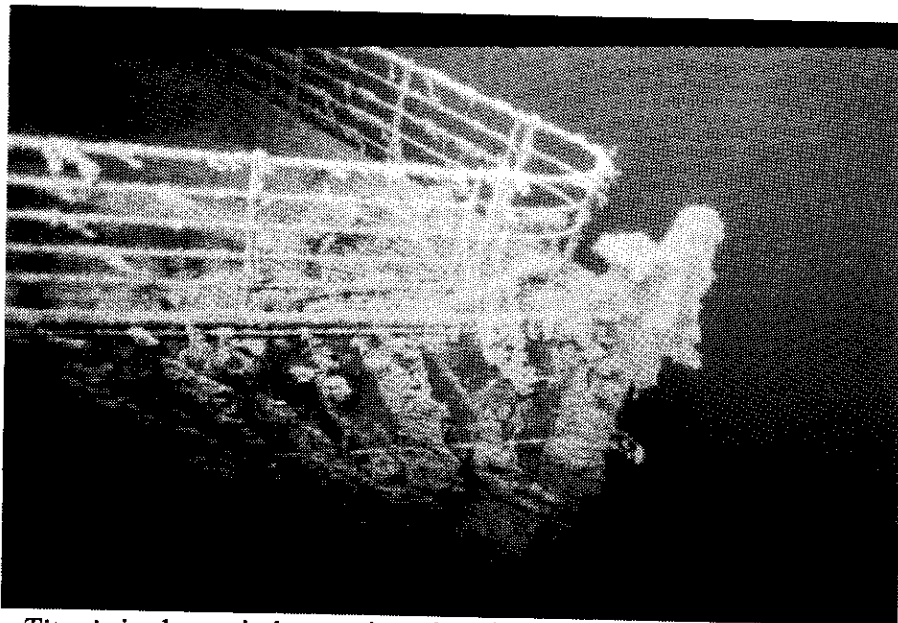
The bow of the *Titanic* is shown in her resting place in August 1996. There is quite a difference between the ship on the ways and in the advanced state of decay. About 20% of the hull has been consumed by "rusticles" which are large colonies of bacteria that are leaching out the iron and other elements in the hull. We estimate in approximately 200 years, the wreck will have collapsed and the elements will be combined with the bottom ocean sediments (Courtesy of RMS Titanic, Inc).

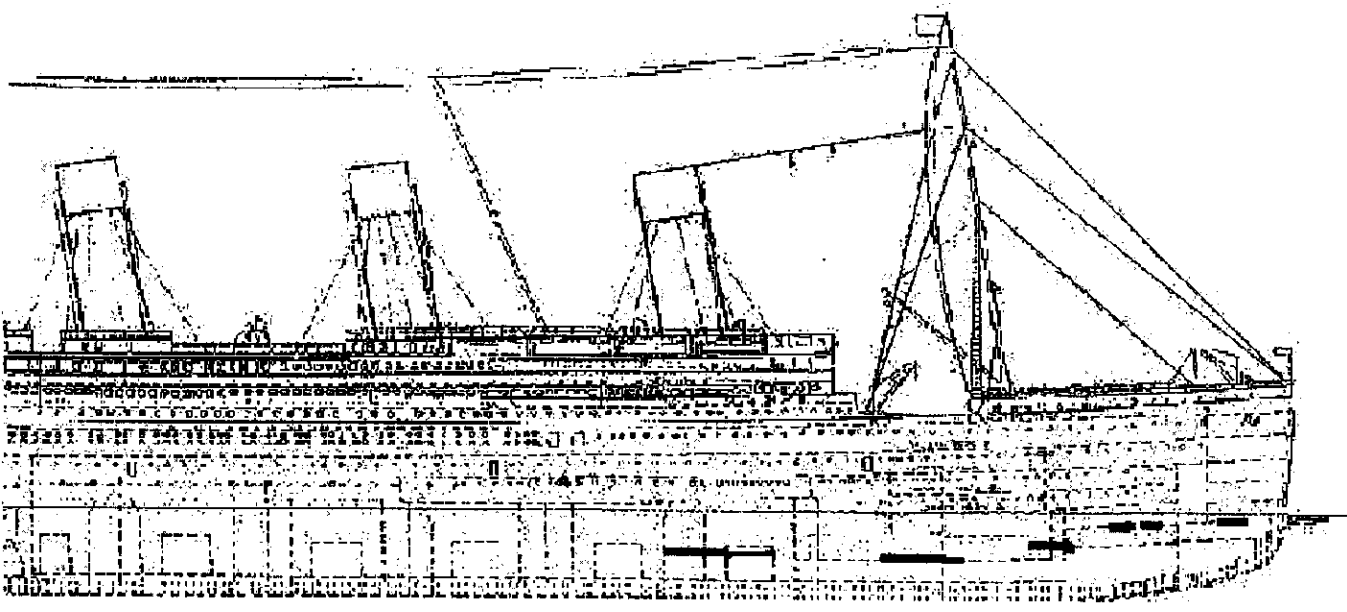
Figure 1 Illustration of the Iceberg Damage

The top portion of the riveted seam of the first full plate below the boot topping was opened in the forepeak and cargo hold number 1. As the ship-iceberg encounter continued, there was fracturing and tearing of this plate between cargo holds Nos. 1 and 2, and parting of the lower portion of that plates riveted seam between Cargo Holds Nos. 2 and 3 and Boiler Rooms Nos. 5 and 6.

Iceberg Damage. How did the *Titanic* encounter the iceberg, and what damage did she sustained? From the results of the sub-bottom profiler survey, we believe that six openings were made in the *Titanic*'s hull in her impact with the iceberg¹⁰, all within a time span of about 11 seconds (see Figure 1). The first brush with the iceberg was a minor glancing blow in the forepeak area just below the waterline near the top of a rivet seam, at a speed of approximately 20 knots. A trace of damage to the side shell was observed at a riveted seam in the sub-bottom profiler of the forepeak, just below the waterline. Because of the narrow bow sections and since the ship was maneuvering to port, this area of the *Titanic* had more of a brushing encounter with the iceberg. However, as the ship continued her forward advance, this brought her back into contact in separate areas of Cargo Hold No. 1 at a speed of less than 20 knots. The profiler discerned two separate areas of damage of 1.2 and 1.5 meters in length along what is believed to be a riveted seam, again just below the waterline. These two encounters were sufficient, however, to shear away a portion of the underwater portion of the iceberg. During these clashes with the ice mass, she was continually slowing from her

As the ship continued to lose speed in her brushes against the iceberg, a fourth opening was made by the iceberg between Cargo Holds Nos. 1 and 2. During this rendezvous, the damage to the ship was further below the waterline as it appears that an upper ledge of ice had been sheared away causing contact further down below the waterline. The sub-bottom profiler shows damage approximately 4.6 meters long at midspan of a plate and in way of a main transverse bulkhead. There was damage about one meter inboard along this bulkhead. It is our contention that the impact forces during this iceberg encounter were sufficient to fracture and tear the plate and transmit structural damage from the main transverse bulkhead between Cargo Hold Nos. 1 and 2 to an inner longitudinal bulkhead that formed the outer boundary of the starboard access to the Firemen's Passage. The structural damage also involved the wrought iron rivets. Stoker Charles Hendrickson noted in his testimony that water was coming through this bulkhead near the bottom of this access. Sonar imaging does show damage along the shell and across the main transverse bulkhead at this level. Although Edward Wilding testified that he thought it to be a penetration by the iceberg that caused this flooding, we do not believe that the iceberg penetrated the ship's plating. First, ice is softer than steel and second, the wrought iron rivets were more likely to fail, opening a seam to flooding.

After the encounter around Cargo Holds Nos. 1 and 2, the ship moved slightly away, but her slower speed and increasing width of hull brought her back in contact for a far more serious blow even further below the water surface. Such contacts were serious because the steel plates and rivets were very susceptible to impact failures. The plate samples retrieved from the seabed had missing rivets and some missing their heads. In addition, one plate had steel pulled out from the rivet hole to the edge of the plate. The sonar imaging shows a large area of damage about 10 meters in length between Cargo Holds Nos. 2 and 3 at a riveted seam. The more severe failure appears to be in Cargo Hold No. 3, substantiating the work of Bedford and Hackett [5] that the damage was most serious in this space. Edward Wilding had also thought that Cargo Hold No. 3 absorbed the brunt of the impact. The damage seen in the sonar imaging also explains why this particular space filled so quickly with water, more so in the first hour than any of the other six compartments affected. By this time, the ship's forward speed had been significantly reduced. Nevertheless, the ship rebounded slightly, and came back again in contact outside Boiler Room No. 6 at the same

In the encounter outside Boiler Rooms Nos. 5 and 6, the energy of impact was less as the ship had begun to turn away from the iceberg. However, it was sufficient to cause a shower of ice to fall from an above-water spar of the iceberg onto the ship. The sonar imaging shows a 13.7-meter length of scraping-type damage of which the most severe damage was the parting of a riveted seam in Boiler Room No. 6 and the forward corner of Boiler Room No. 5. There is also a large dent in the hull in the forward end of Boiler Room No. 5, near the main transverse watertight bulkhead between these two spaces. At this point, as the ship began to turn away from the iceberg, there was a compressive pivoting action against the ice, causing this dent in the shell plating in the area of the main transverse bulkhead between Boiler Rooms Nos. 5 and 6.

The damage to the shell plating outside of Cargo Hold No. 3 was the most severe in the encounter with the iceberg and is the reason why this particular watertight compartment flooded so rapidly. The damage in this area of the ship also fits Edith Russell's and Edith Haisman's accounts of the severity of the third encounter with the iceberg as a very strong jolt. In all probability, because of the damage it received, this compartment filled faster than the other spaces involved in the collision. Flooding water from Cargo Hold No. 3 probably overflowed into those compartments forward of this cargo hold before they were filled by their own flooding action. Another important aspect of the flooding was that a number of portholes were left open by the crew and passengers for fresh air or by the curious to determine what the ship had hit. These openings were additional sources of water intake during a later phase of the ship's sinking process.

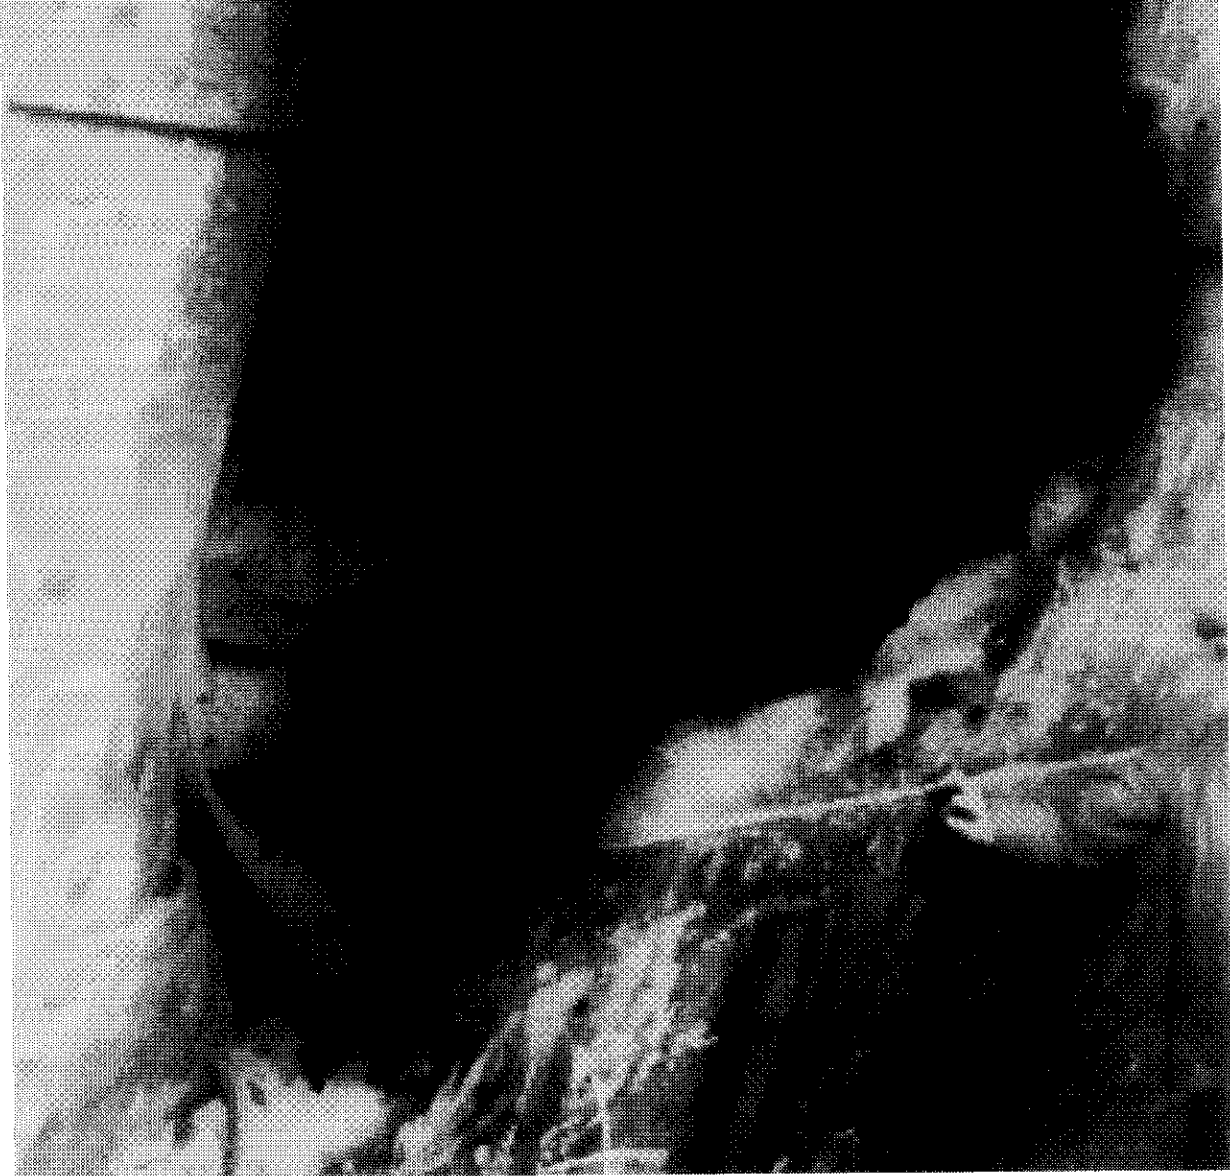
This is a view of the collision damage to the RMS *Olympic* in her collision with the cruiser HMS *Hawke* on September 20, 1911 in the Solent, south of the port of Southampton. The waters in the Solent at that time of year were much warmer than the area in which her sister collided with ice some seven months later. Note the fracturing around the rivets in the upper portion of the hole in way of the rivets. (Courtesy of Charles Haas and John Eaton, "*Titanic*, Triumph and Tragedy")

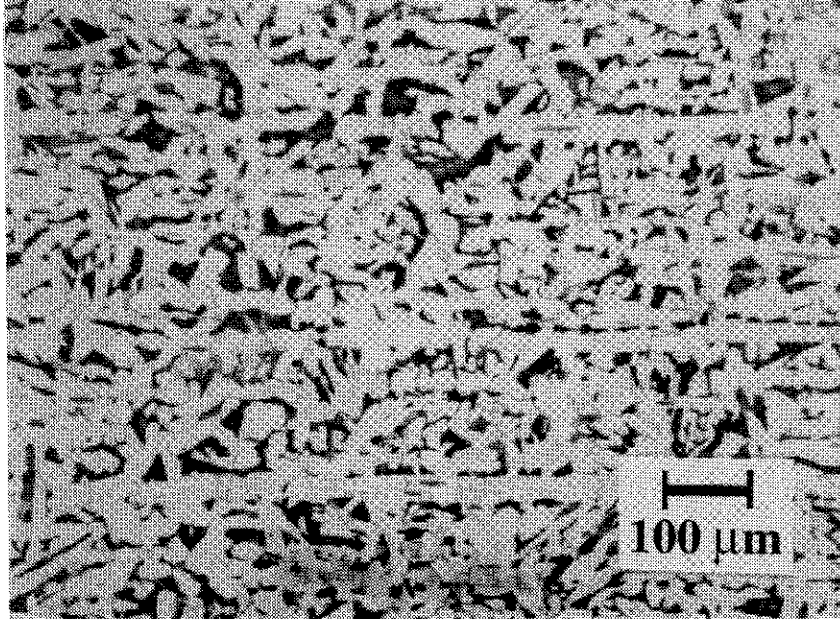
Figure 2

The chemical tests of the steel, summarized in Table 2, indicated higher percentages of sulfur, phosphorous, and oxygen than would be permitted by classification societies rules in modern mild steel plates or stiffeners. The differences in chemical analysis are due to variability in steel production. The results of the 1996 analysis of the hull pieces have also been compared with the 1991 tests of a hull piece done by CANMET of Ottawa, Canada. The tests done by CANMET and the University of Missouri - Rolla, on the two different hull plates show remarkable agreement in the percentages of the steel's major elements, with the exception of phosphorous. This can be attributed to the chemical testing or a different source of iron ore used by the steel mill. Certain European iron ores are known to have higher percentages of phosphorous than others. CANMET did not test for the oxygen content, but good present-day practice is to have the oxygen level at no more than 0.01%. Excess oxygen in the steel ingot has the tendency to form precipitates which also can embrittle the steel. Dissolved oxygen will also drive the transition temperatures to higher values.

The sulfur content of this steel is important in understanding the fracture mechanics of the hull failure of the *Titanic*. Sulfur and manganese react to form manganese sulfide. Without manganese, the steel would have iron sulfide formed at the grain boundaries. The iron sulfide has a low melting point so the steel ingot would have a grain boundary envelope which, at rolling temperatures, would be molten. Since a liquid phase will not resist shear stresses, hot work (e.g.: by rolling) would

An optical micrograph of the *Titanic* hull plate in the longitudinal direction.

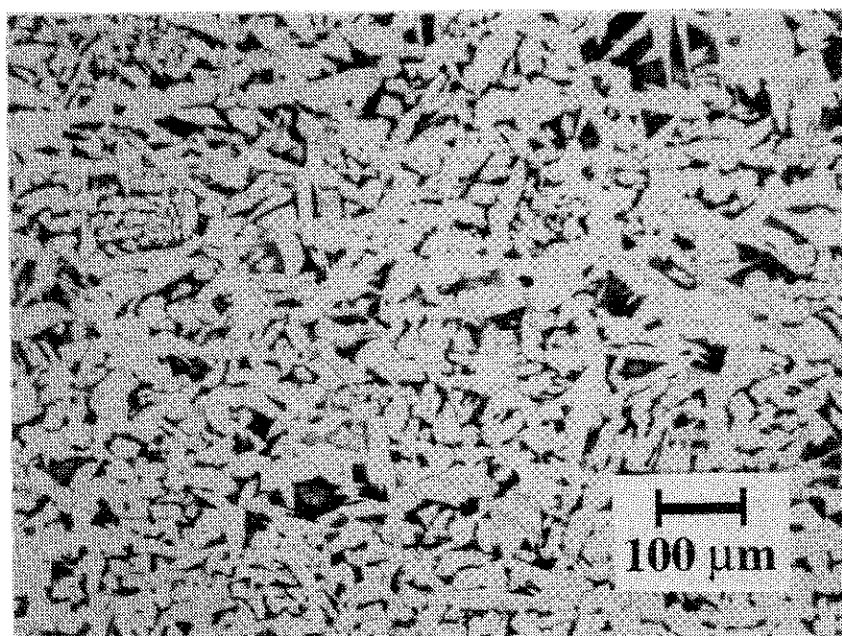
Figure 3

An optical micrograph of the *Titanic* hull plate in the transverse direction.

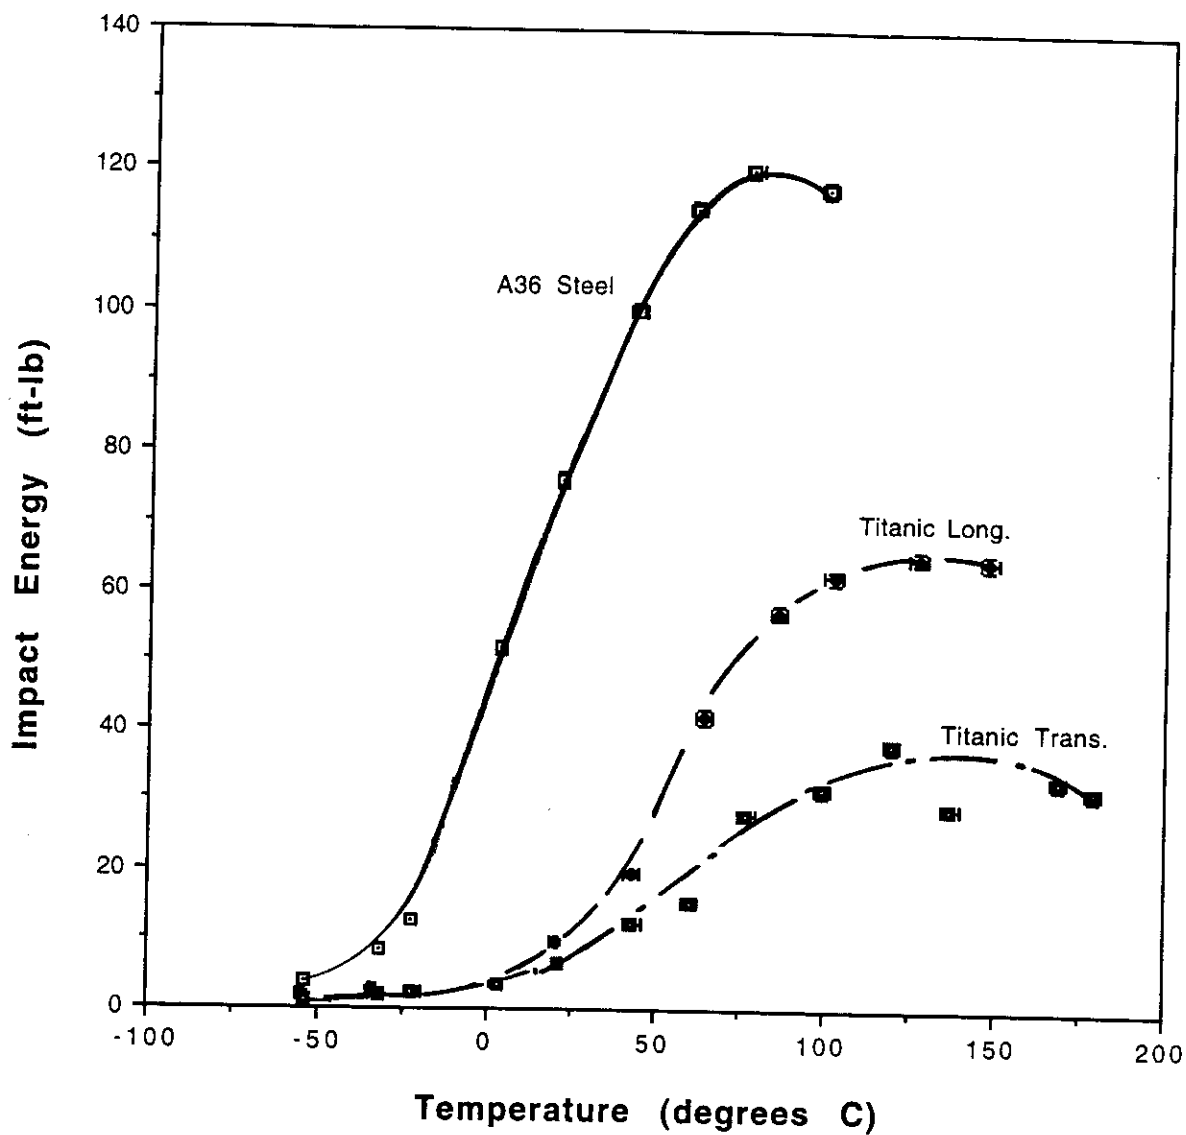
Figure 4

Charpy V-Notch Test of *Titanic* Steel Versus a Modern A 36 Steel

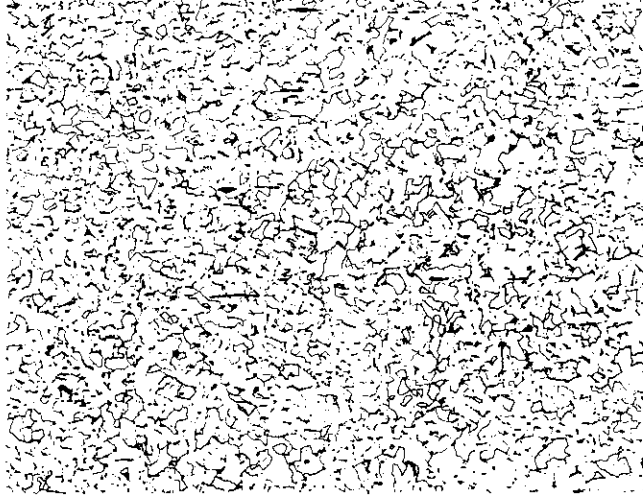
Figure 5

Nomadic Plate, Longitudinal Optical Micrograph

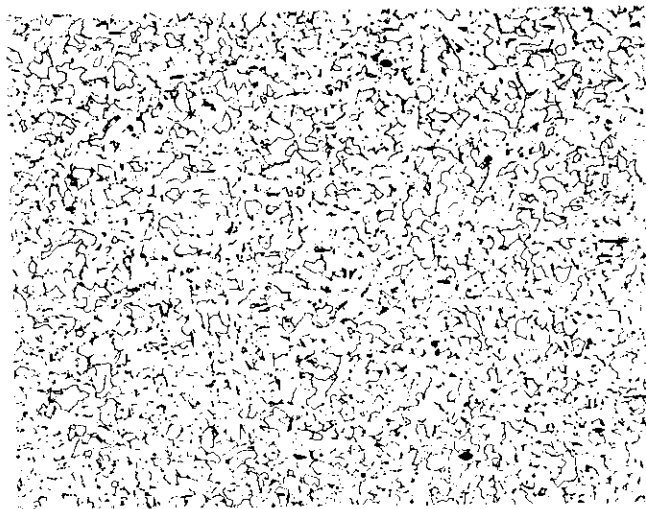
Figure 6

Nomadic Plate, Transverse Optical Micrograph

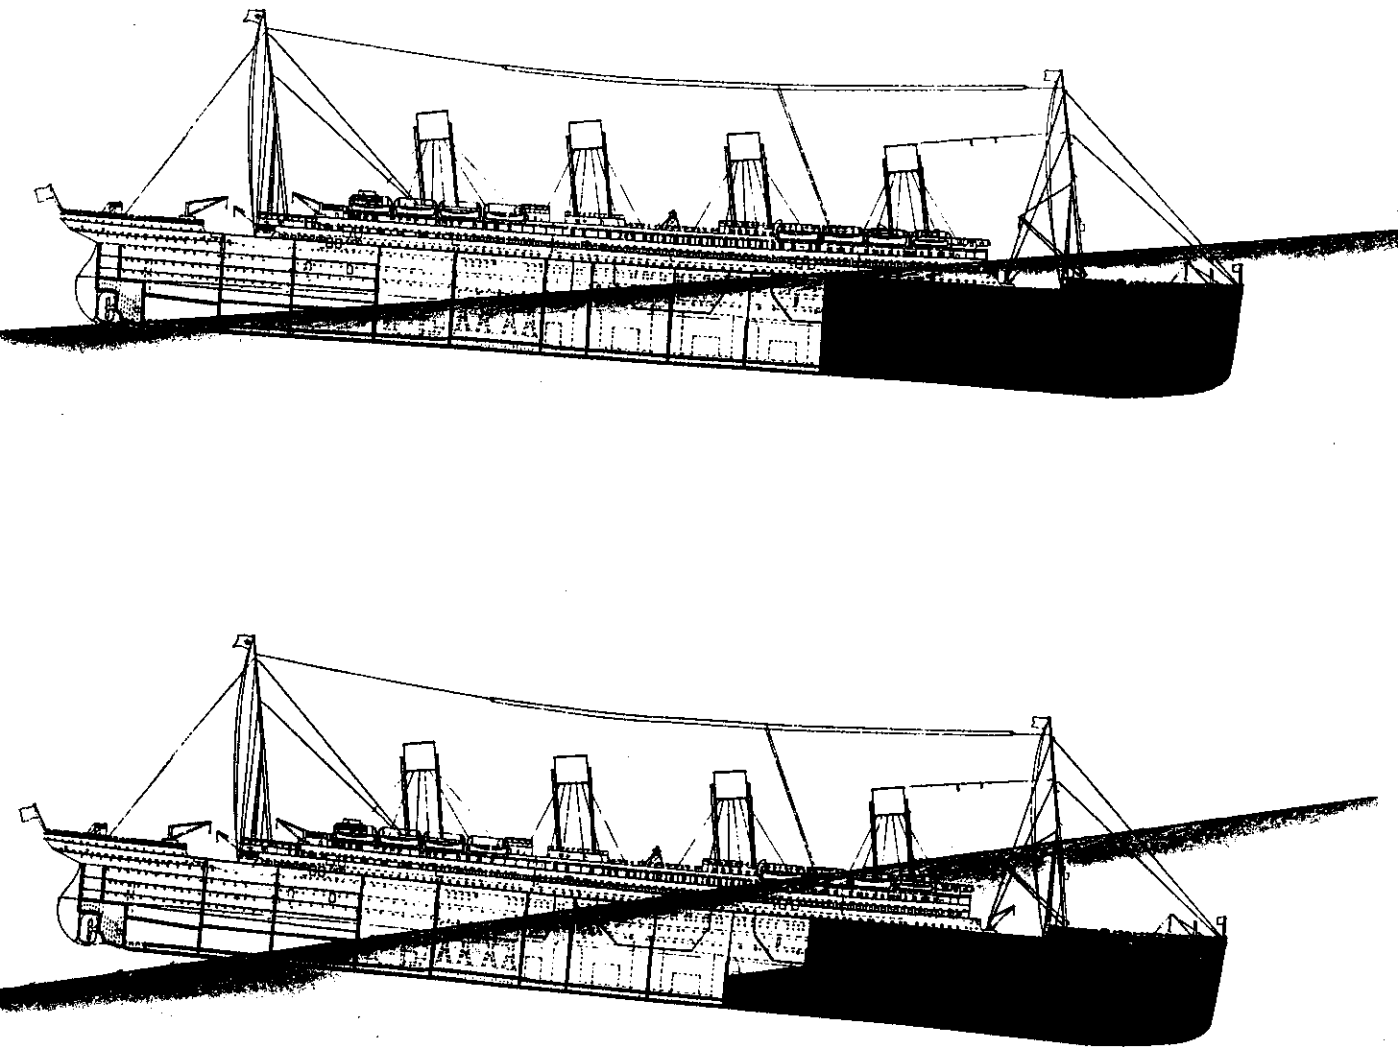
Figure 7

The flooding diagrams of Conditions C-6 and C-7 from Reference [5].

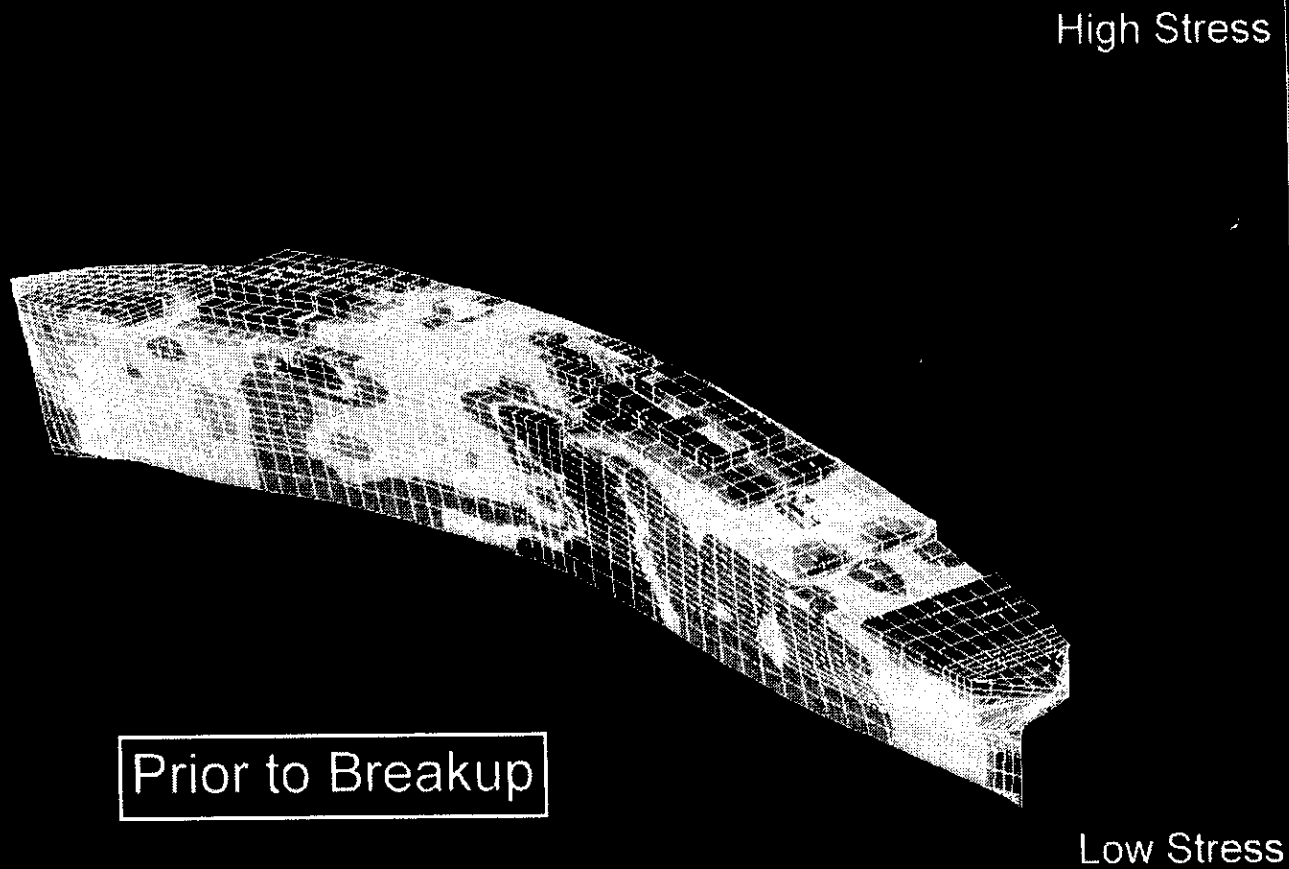
Figure 9

Finite Element Model Results of *Titanic* "Before Breakup".

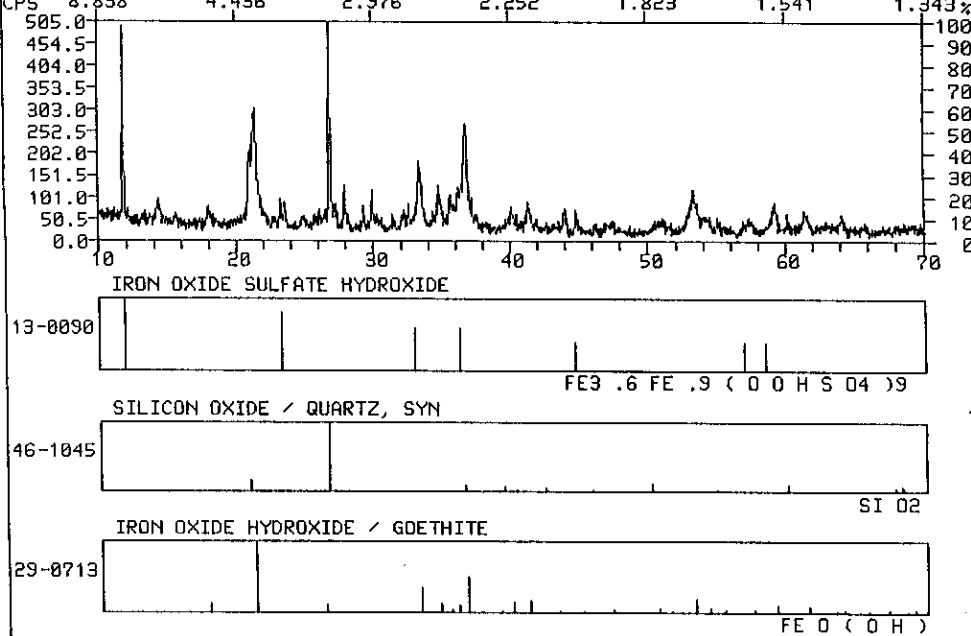
Figure 10

Mr. Scott Miller of the Department of Metallurgical Engineering at the University of Missouri-Rolla examined samples of rusticles using a scanning electron microscope. He performed elemental analysis, as well as semi-quantitative analysis. The result is given in Figure 10. As expected, Iron (Fe) is the dominant element present, followed by Sulfur. The sulfur is present as the sulfate ion, SO_4^- , could be from the sulfur in the steel or more likely from the sea water which has 884 part per million content of sulfur [12] The silicon will be shown to be mechanically entrained as silica, SiO_2 , from the ever-present sand at the ocean bottom.

Elemental Analysis and Semi-quantitative Analysis of a Rusticle.

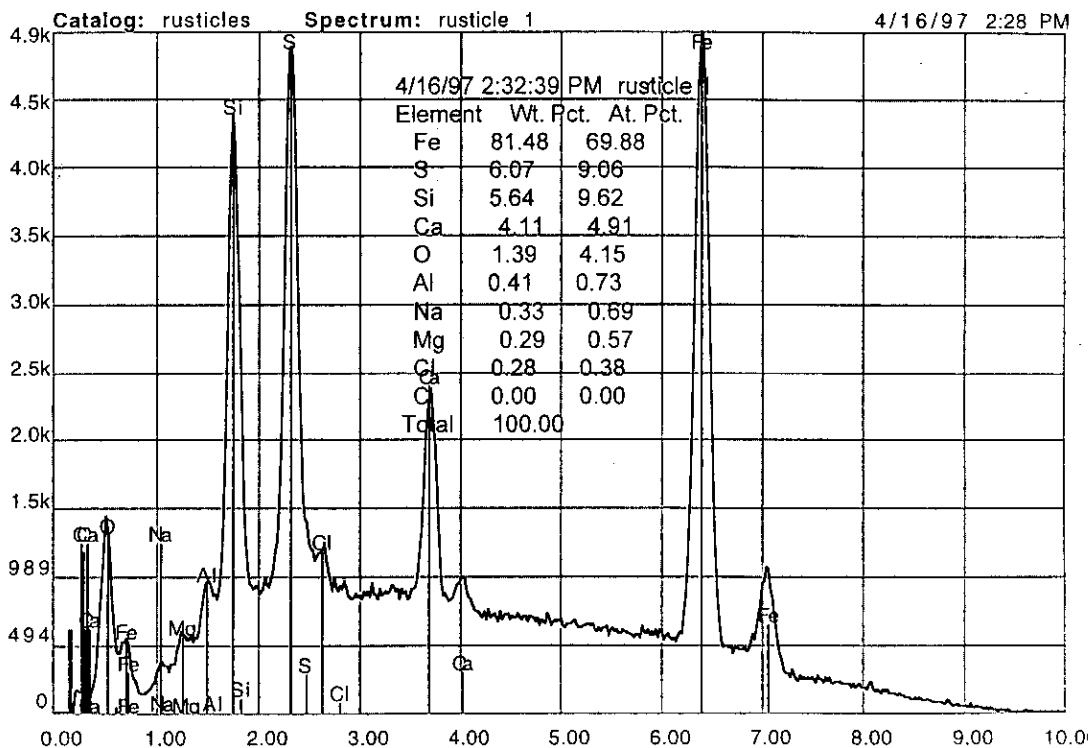
Figure 11

Dr. Mark Shumsky of the Materials Research Center at the University of Missouri-Rolla performed x-ray diffraction determinations to identify the compounds in a sample taken from a rusticle and from a massive piece of the corrosion product taken from a piece of steel. The same three compounds were found in these two samples, but in differing concentrations in each sample; silica, which is sand and discussed in the previous paragraph, goethite ($\text{FeO}(\text{OH})$), and iron oxide sulfate, also known

Diffraction Pattern of a Rusticle.
